Manhole Inspection Summary

Manhole # S19CC1018MH

Insp Date: **6/29/07 8:08 AM**

Location Address: **3601 DRUID HILL PARK DR** Cross Street: **KEYSTONE AVE**

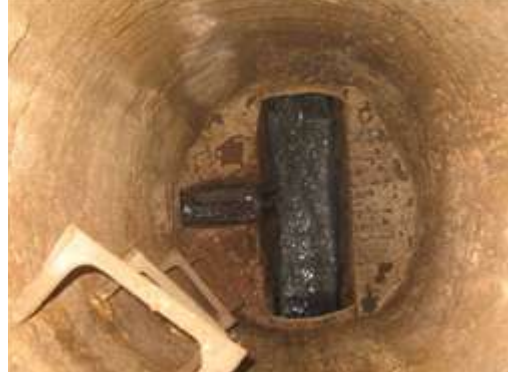
Top View

Bench debris.

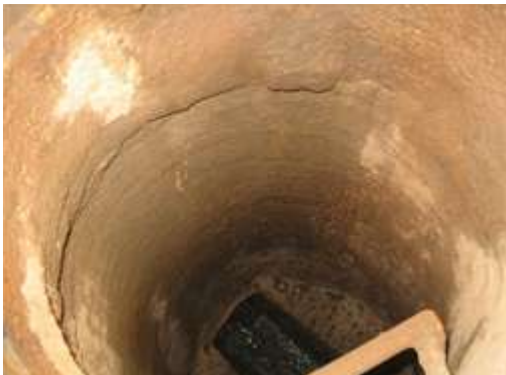
Defect

Frame leaks. Adjustment, Corbel and Barrel infiltration.

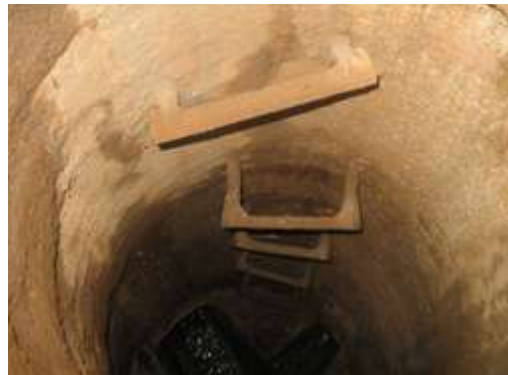
Defect

Barrel infiltration.

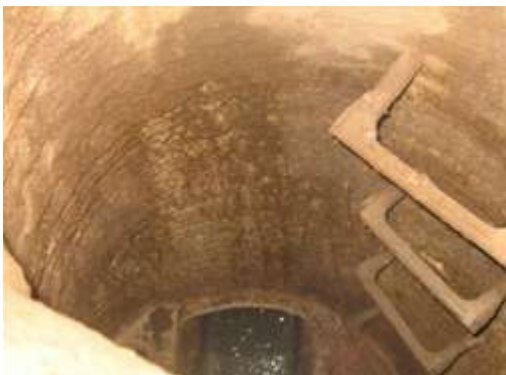
Defect

Adjustment and Corbel infiltration.

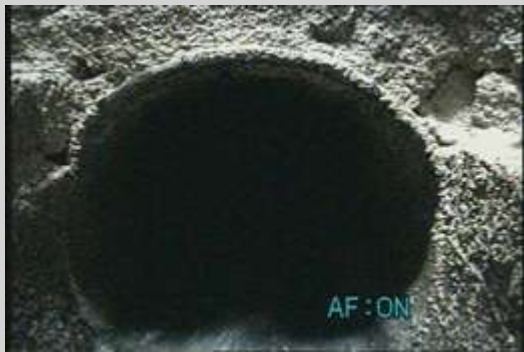
20 in. Circular Gravity Sewer Pipe Out @ 12 O'Clock

Invert Depth: **11.58** (ft.) Flow Characteristics: **Fast**

Deposits: ☒ None ☐ Mud ☐ Sludge ☐ Debris ☐ Grease

Infiltration: **None** Pipe Seal Cond: **Unknown**

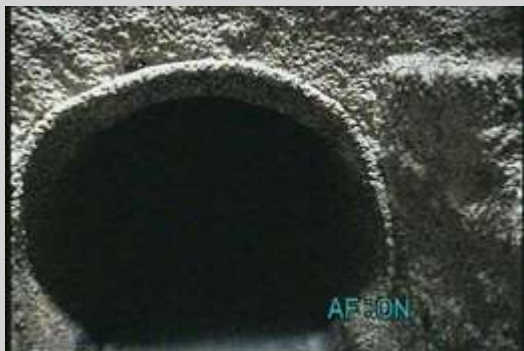
16 in. Circular Gravity Sewer Pipe In @ 6 O'Clock

Invert Depth: **11.50** (ft.) Flow Characteristics: **Fast**

Deposits: ☒ None ☐ Mud ☐ Sludge ☐ Debris ☐ Grease

Infiltration: **None** Pipe Seal Cond: **Unknown**

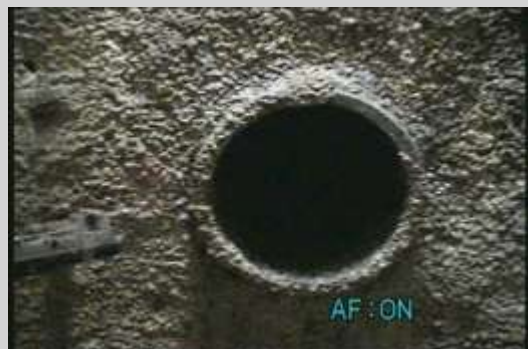
Pipe In @ 9 O'Clock

Invert Depth: **8.70** (ft.) Flow Characteristics: **Fast**

Deposits: ☒ None ☐ Mud ☐ Sludge ☐ Debris ☐ Grease

Infiltration: **None**

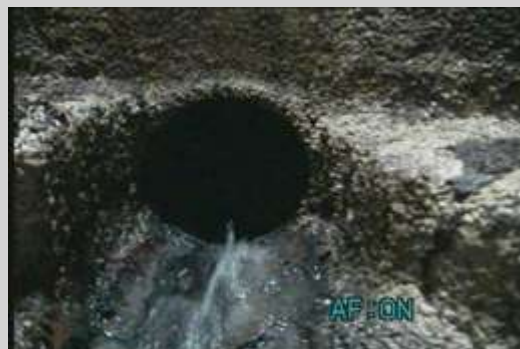
Drop In @ 9 O'Clock

Drop: **Outside** Rod and Bar

Angled: **Yes** Reading: **9.62** (ft.)

Inv Depth: **10.62** (ft.)

Drop Condition: **Open**
